Indiana Department of Environmental Management

Re: Inspection Summary/ Enforcement Referral
US Steel Corporation Midwest Plant
NPDES Permit No. IN0000337
Portage, Porter County

NPDES Industrial Facility Inspection Report

Inspection Photographs

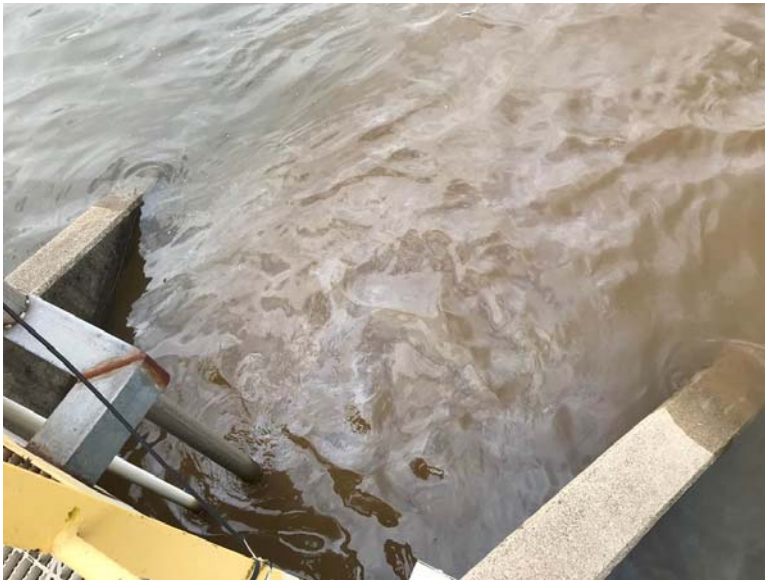
At the time of the inspection, on the morning of May 9, 2019, it was noted that the receiving stream near Outfall 004 was reddish-brown in color and appeared to contain solids. An oil sheen at Outfall 004 was also observed during the morning of May 9, 2019. US Steel Midwest personnel placed a boom at Outfall 004 at the request of David Greinke with the IDEM Emergency Response Section. Much of the solids, discoloration and sheening appeared to have dissipated by 2 PM on May 9, 2019.

Location/Description:
West and down view of Outfall 004 into Burns Waterway. The effluent was brownish-red and turbid. Light sheening was visible.

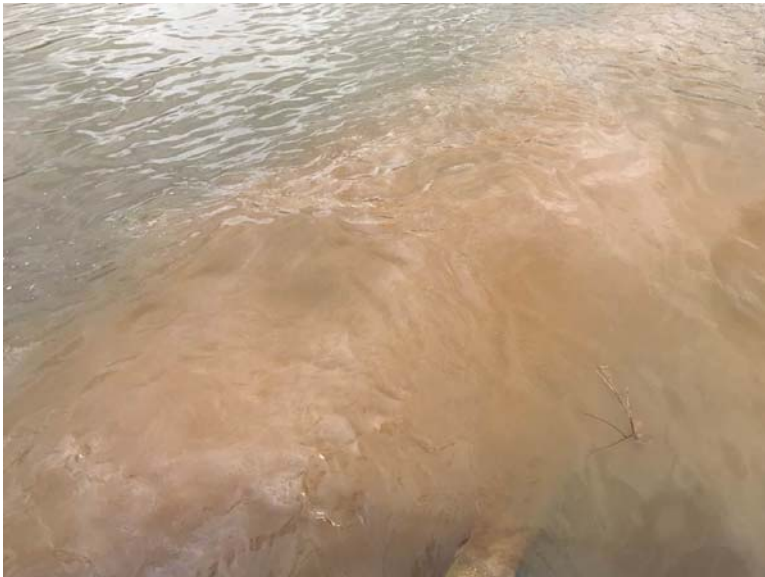
Location/Description:
West and down view of Outfall 004 into Burns Waterway. The effluent was brownish-orange and turbid. Light sheening was visible.

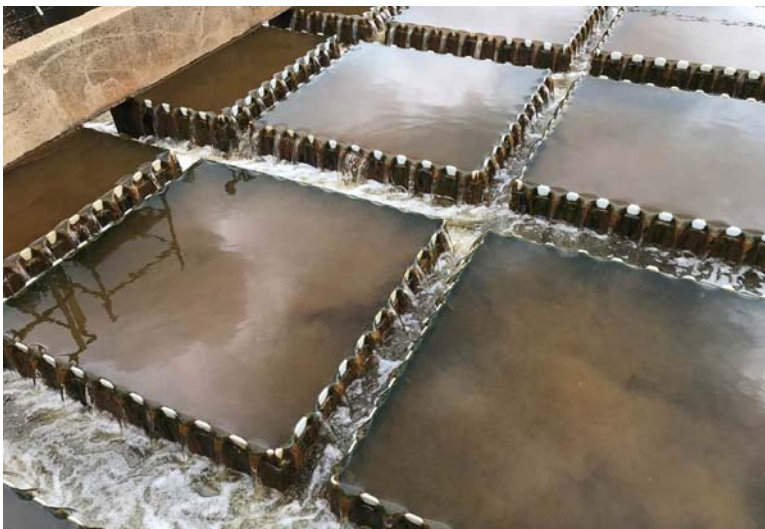
Location/Description:
East view of the clarifiers of the east treatment train of Final Treatment. Brownish-orange solids were observed overflowing the weirs.

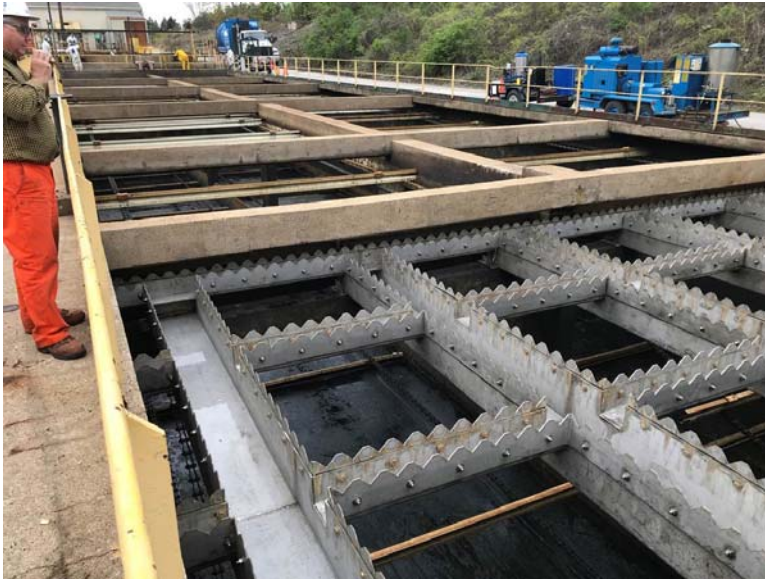
Location/Description:
Southern view of the Final Treatment - West Train, which was down for routine maintenance.

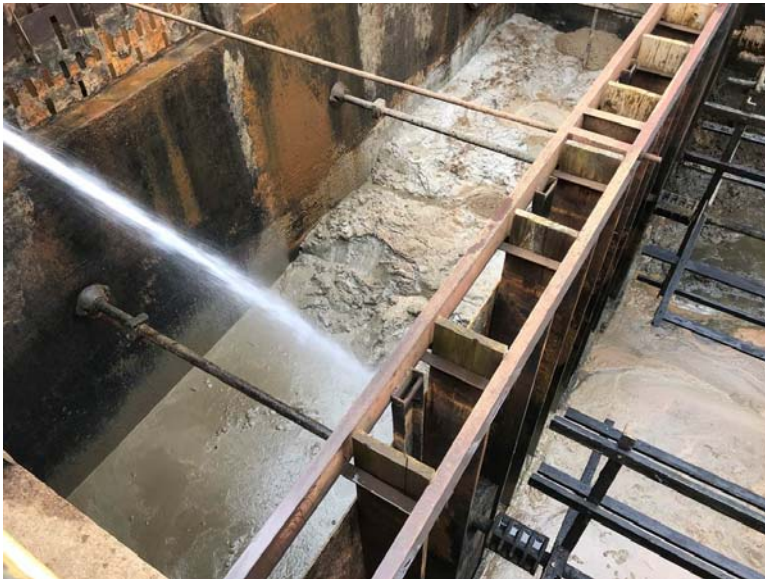
During the problem with the sulfuric acid release from the Tin Line, the western train of Final Treatment was off-line for maintenance. Due to oil and grease in the bottom of the tank being cleaned, there were concerns by the operator regarding the loss of oil and grease to Burns Waterway if the western train was immediately put back into service. While this may be a valid reason to not put the line into service, there was insufficient capacity in the single operating train to remove the solids generated. The operational loss of available capacity likely caused or contributed to the loss of the solids to Burns Waterway and, thus, to Lake Michigan, which caused violations of the Narrative Water Quality Standards.

Location/Description:
Southwest and down view of the oil and grease being cleaned out of the west treatment train of Final Treatment.

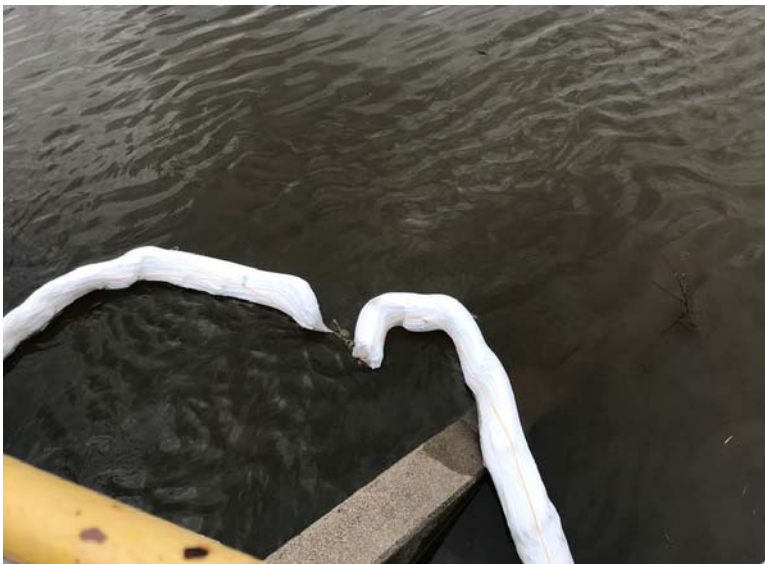
Location/Description:
A boom was placed at Outfall 004 at the request of David Greinke. Corrections were made to the boom shortly after the picture was taken.

After entering the facility, Mr. Greinke and Mr. Ream met with Mr. Mark Henry and Mr. Tim Sullivan. Mr. Greinke recommended the placement of an oil absorbent boom to capture the sheen in Burns Waterway. Orange solids were overflowing the weirs of the east treatment train of the Final Treatment WWTP. The west treatment train was off-line for routine maintenance. When asked why the west train was not brought on-line due to the loss of solids, Mr. Henry stated that a thick layer of oil and grease was being cleaned from the off-line train and he had concerns that starting the train would result in washing

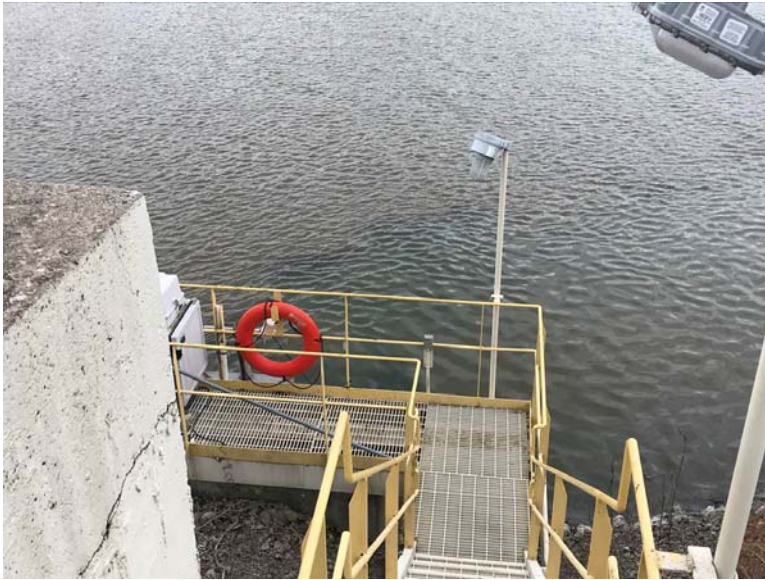
Location/Description:
West and down view of Outfall 004. The loss of solids had diminished dramatically by approximately 2:00 PM CST.

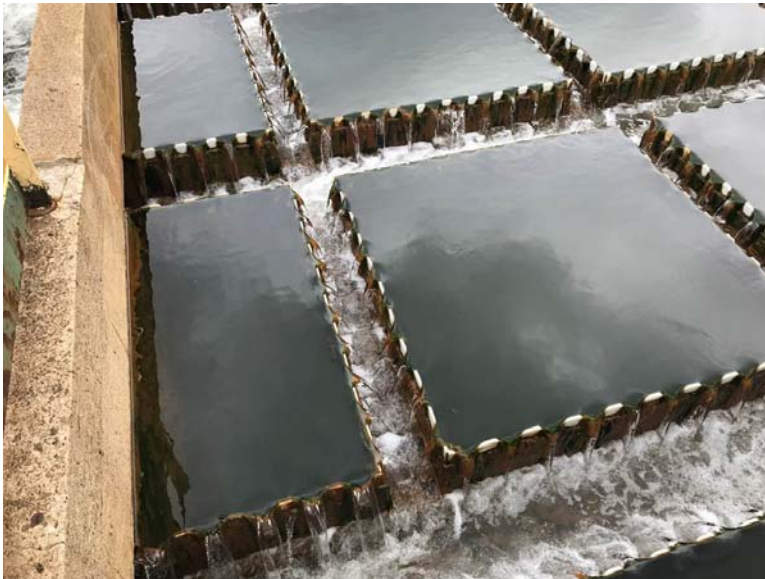
Location/Description:
East view of the clarifiers of the east treatment train of Final Treatment. The loss of solids had diminished dramatically by approximately 2:00 PM CST.
